# Debris/Ice/TPS Assessment And Photographic Analysis For Shuttle Mission STS-48

**Gregory N. Katnik**  
NASA/Kennedy Space Center

DEBRIS/ICE/TPS ASSESSMENT  
AND  
PHOTOGRAPHIC ANALYSIS  
OF  
SHUTTLE MISSION STS-48

September 12, 1991

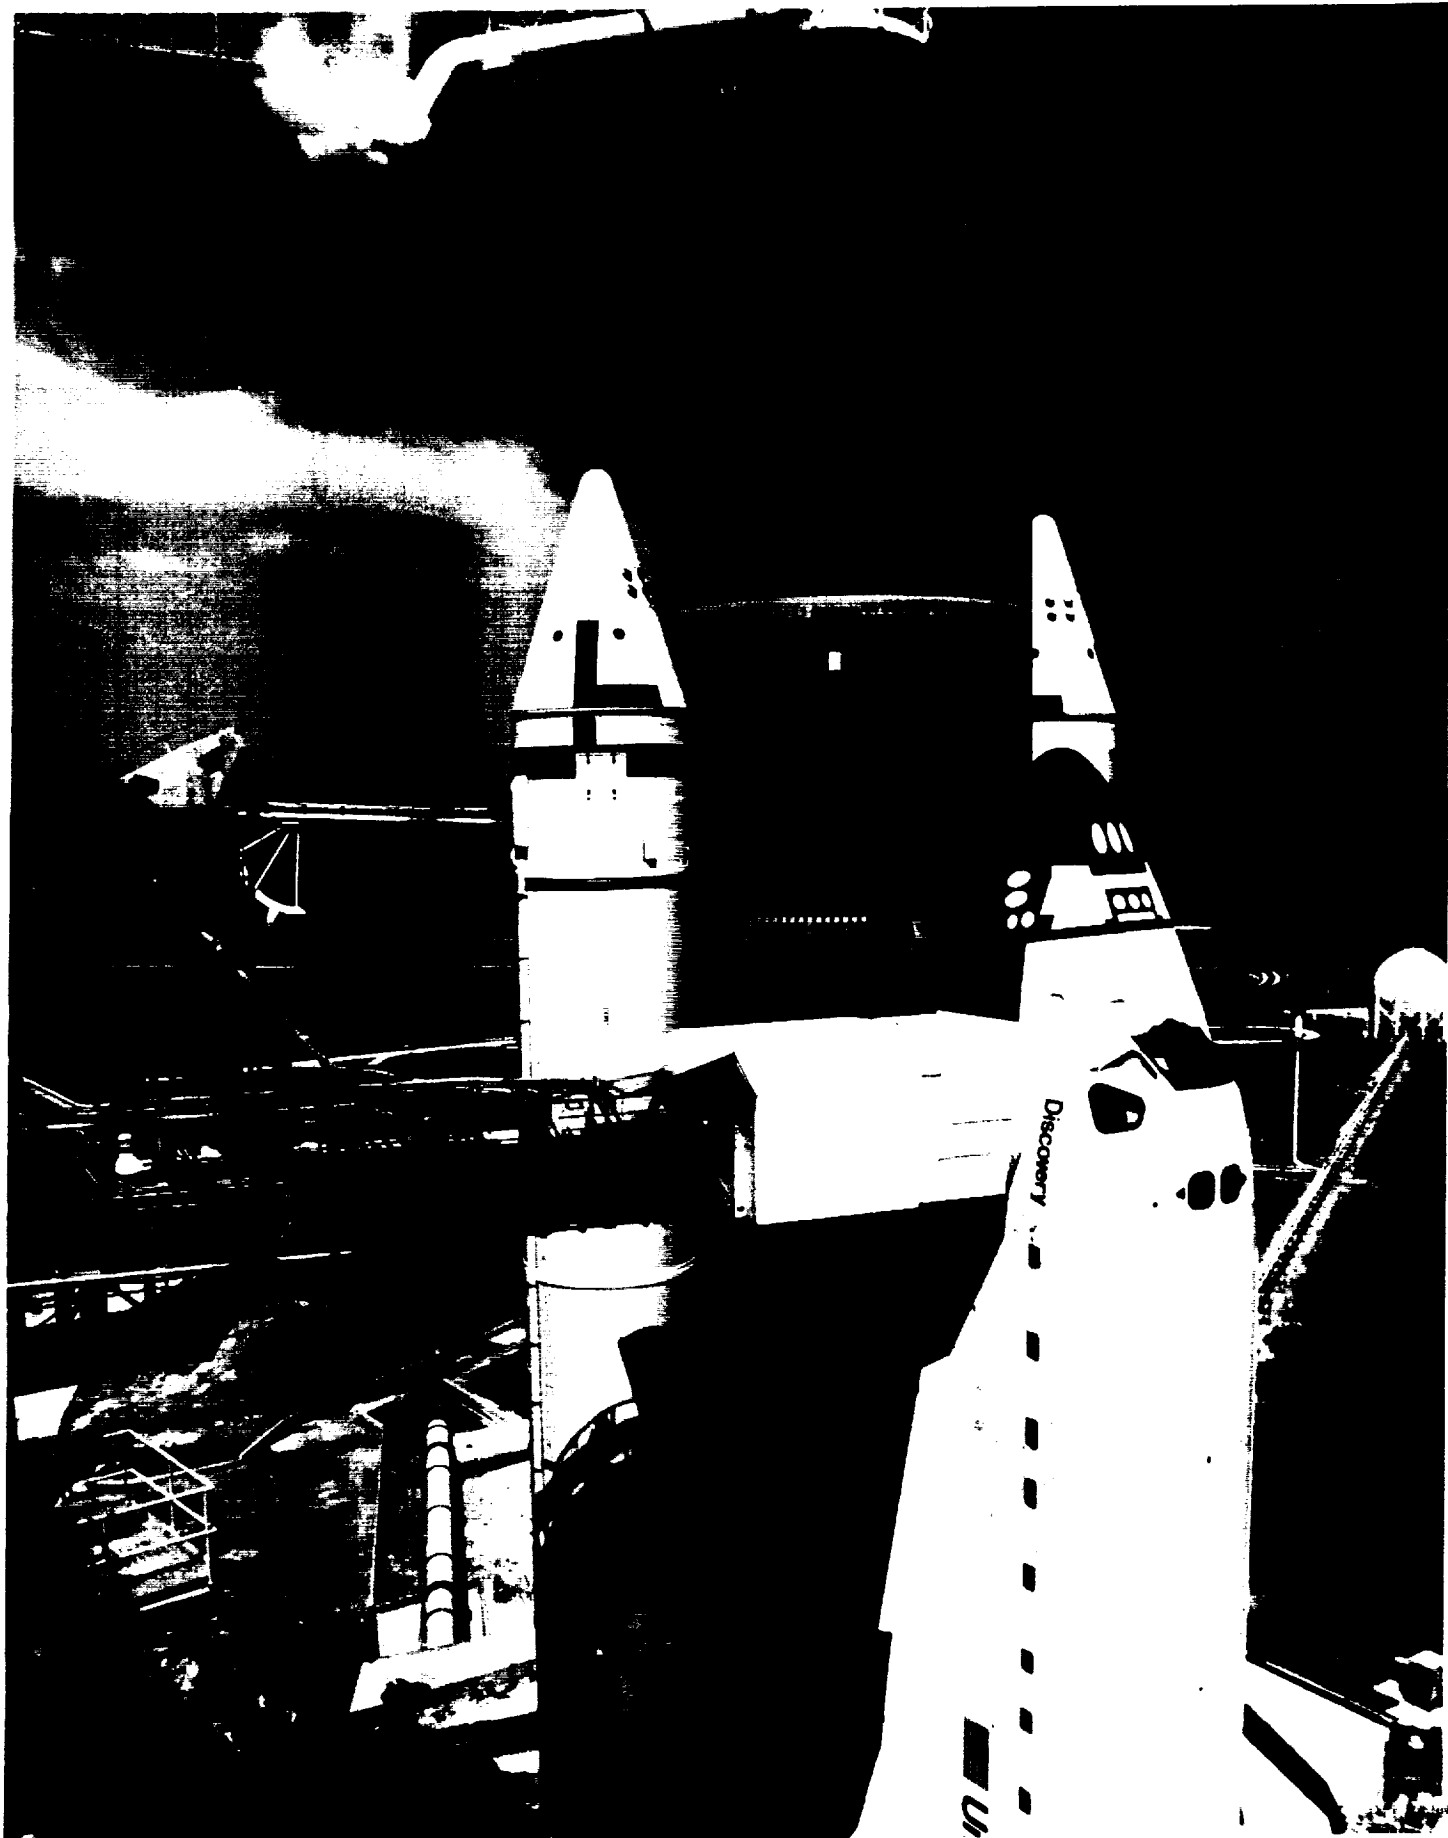
There were no TPS anomalies or ice/frost accumulations on the  
External Tank acreage

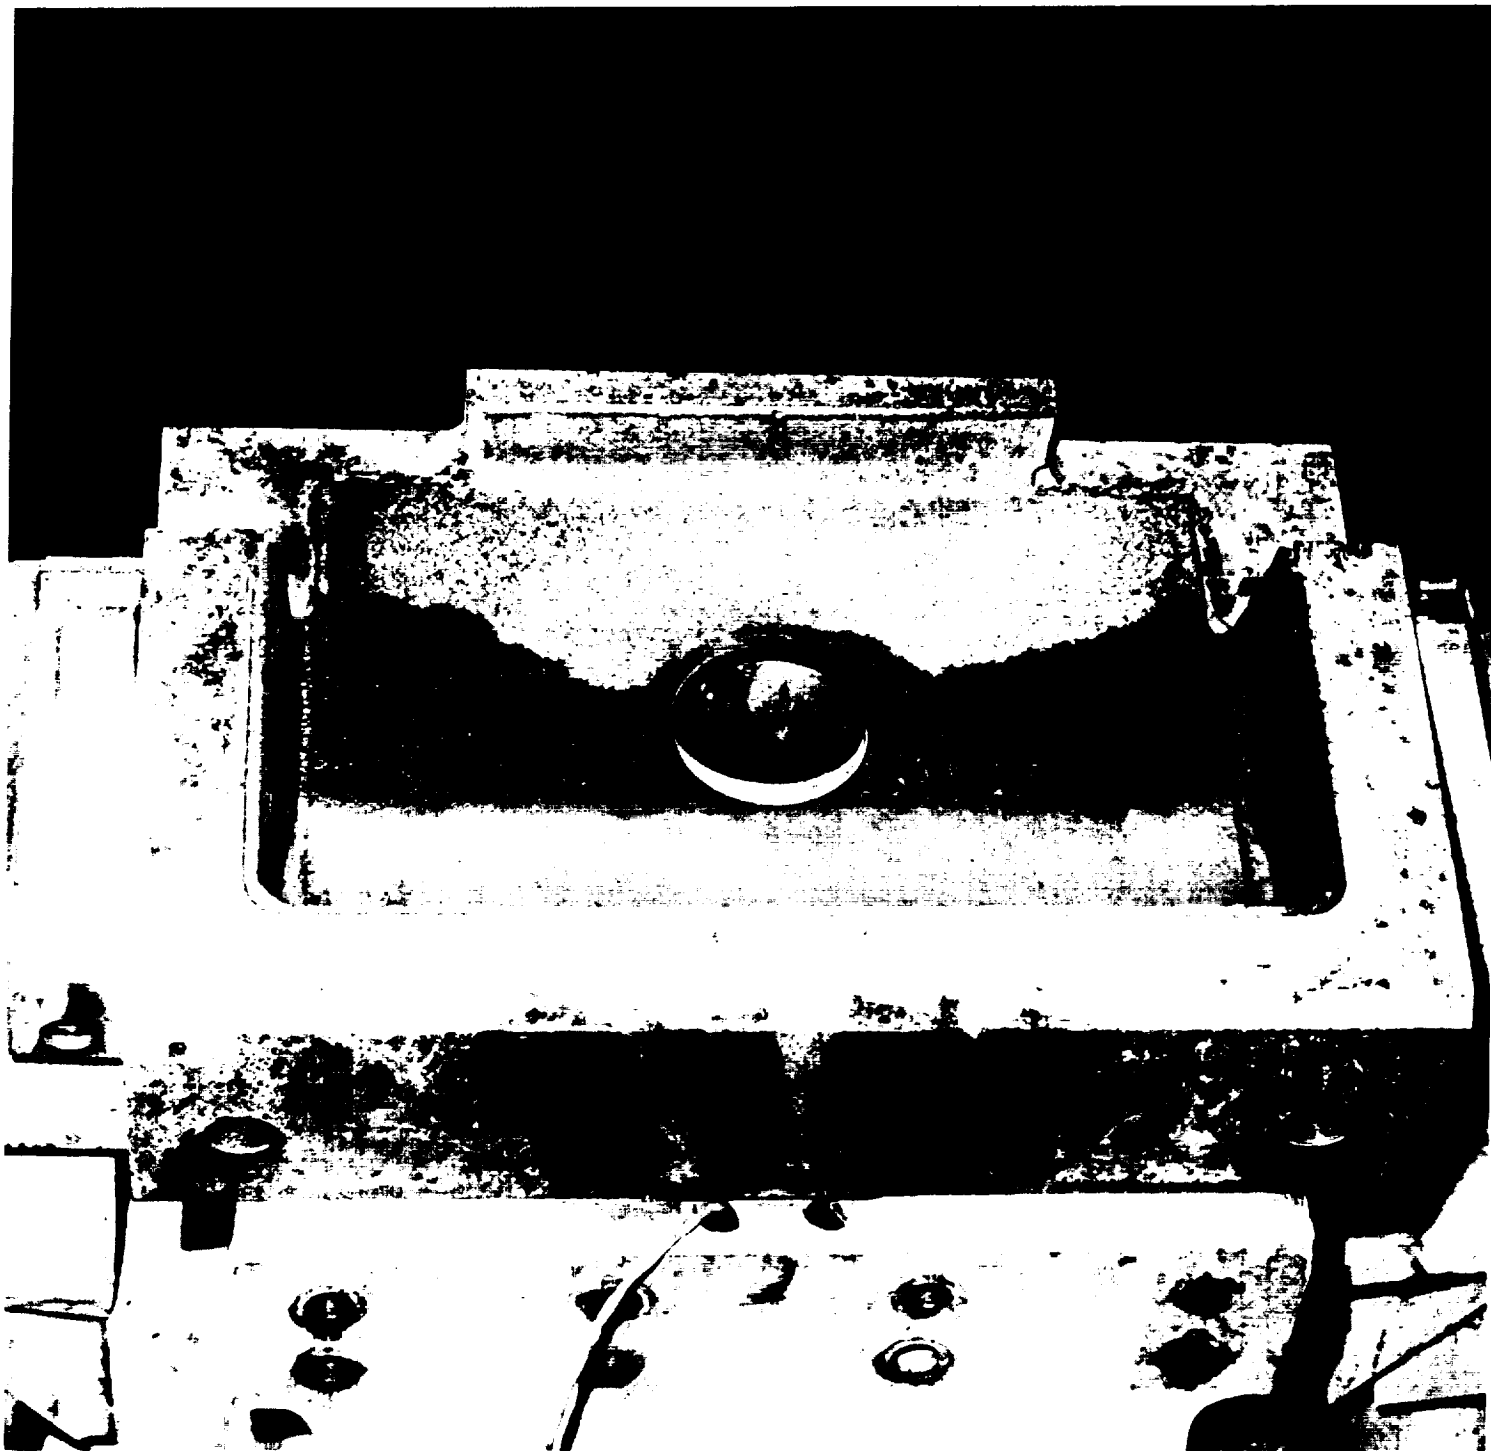
Plume erosion of the south SRB holddown posts was typical. All EPON shim sidewall material and shim bottom plate material was intact and bonded to the shoes. There was no visual indication of a stud hang-up on any of the south holddown posts.

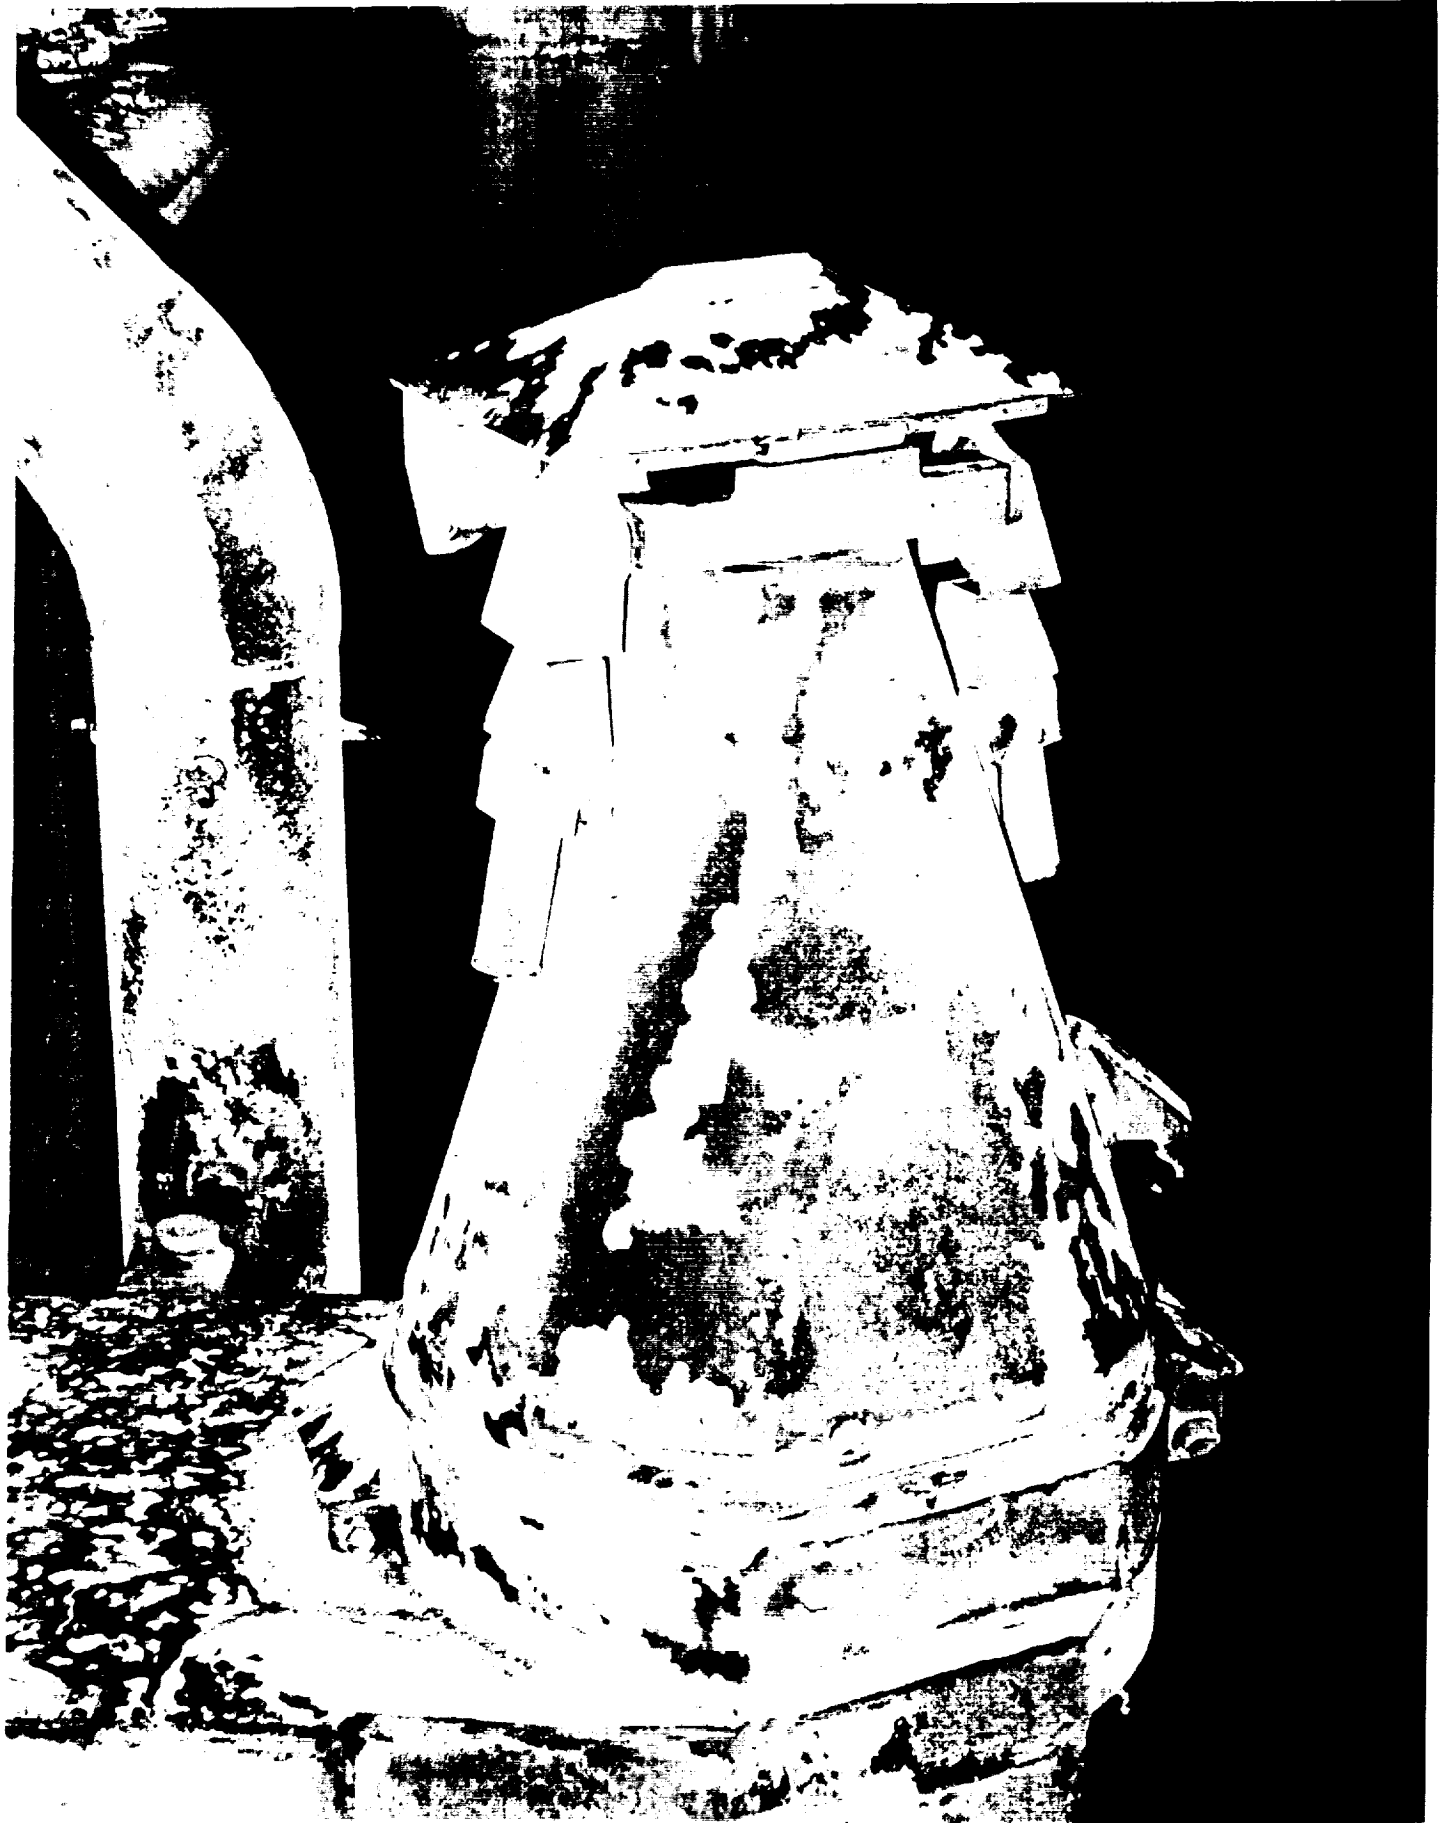
North HDP blast covers were in the closed position and exhibited typical SRB plume erosion effects

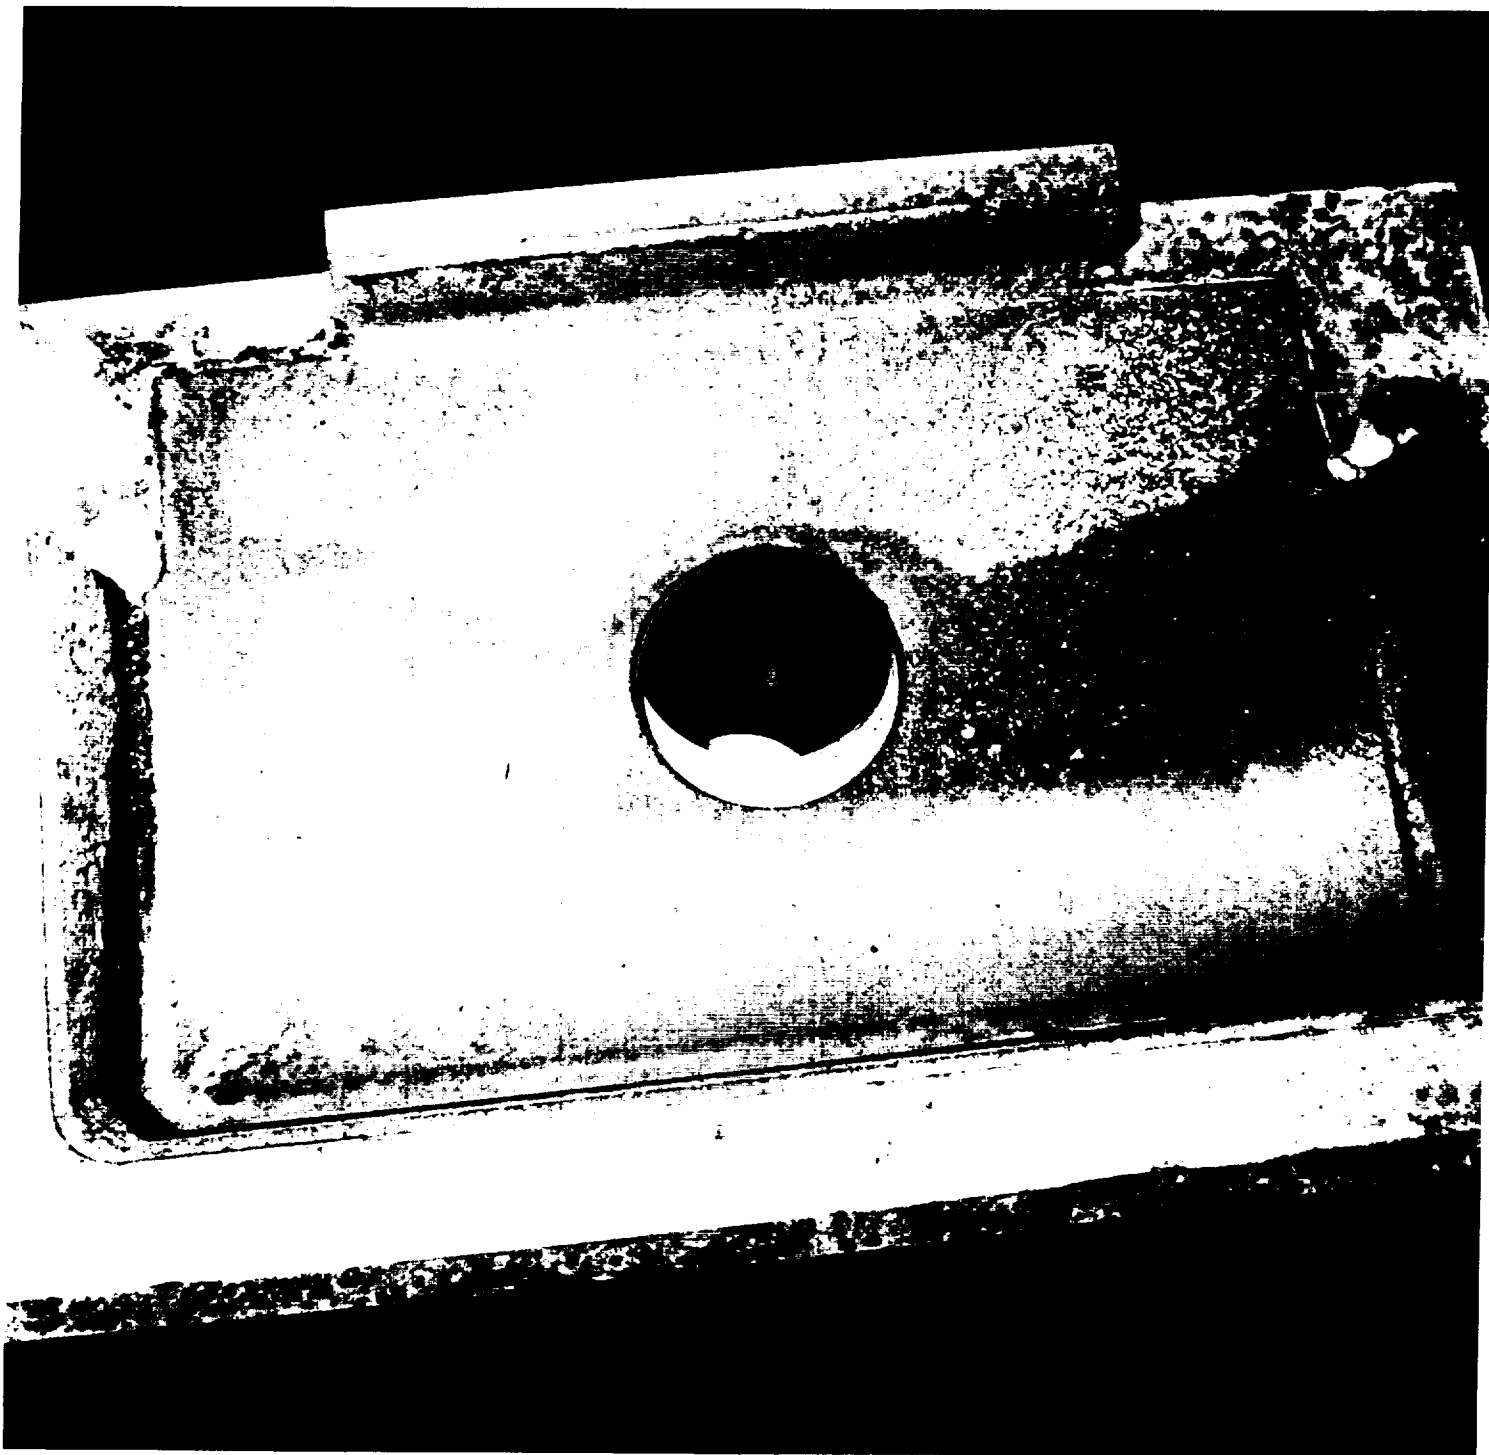
Frangible nut/ordnance fragments lay on the stud in HDP #5. These fragments had not been retained by the Debris Containment System (DCS) and fell from the aft skirt stud hole shortly after liftoff.

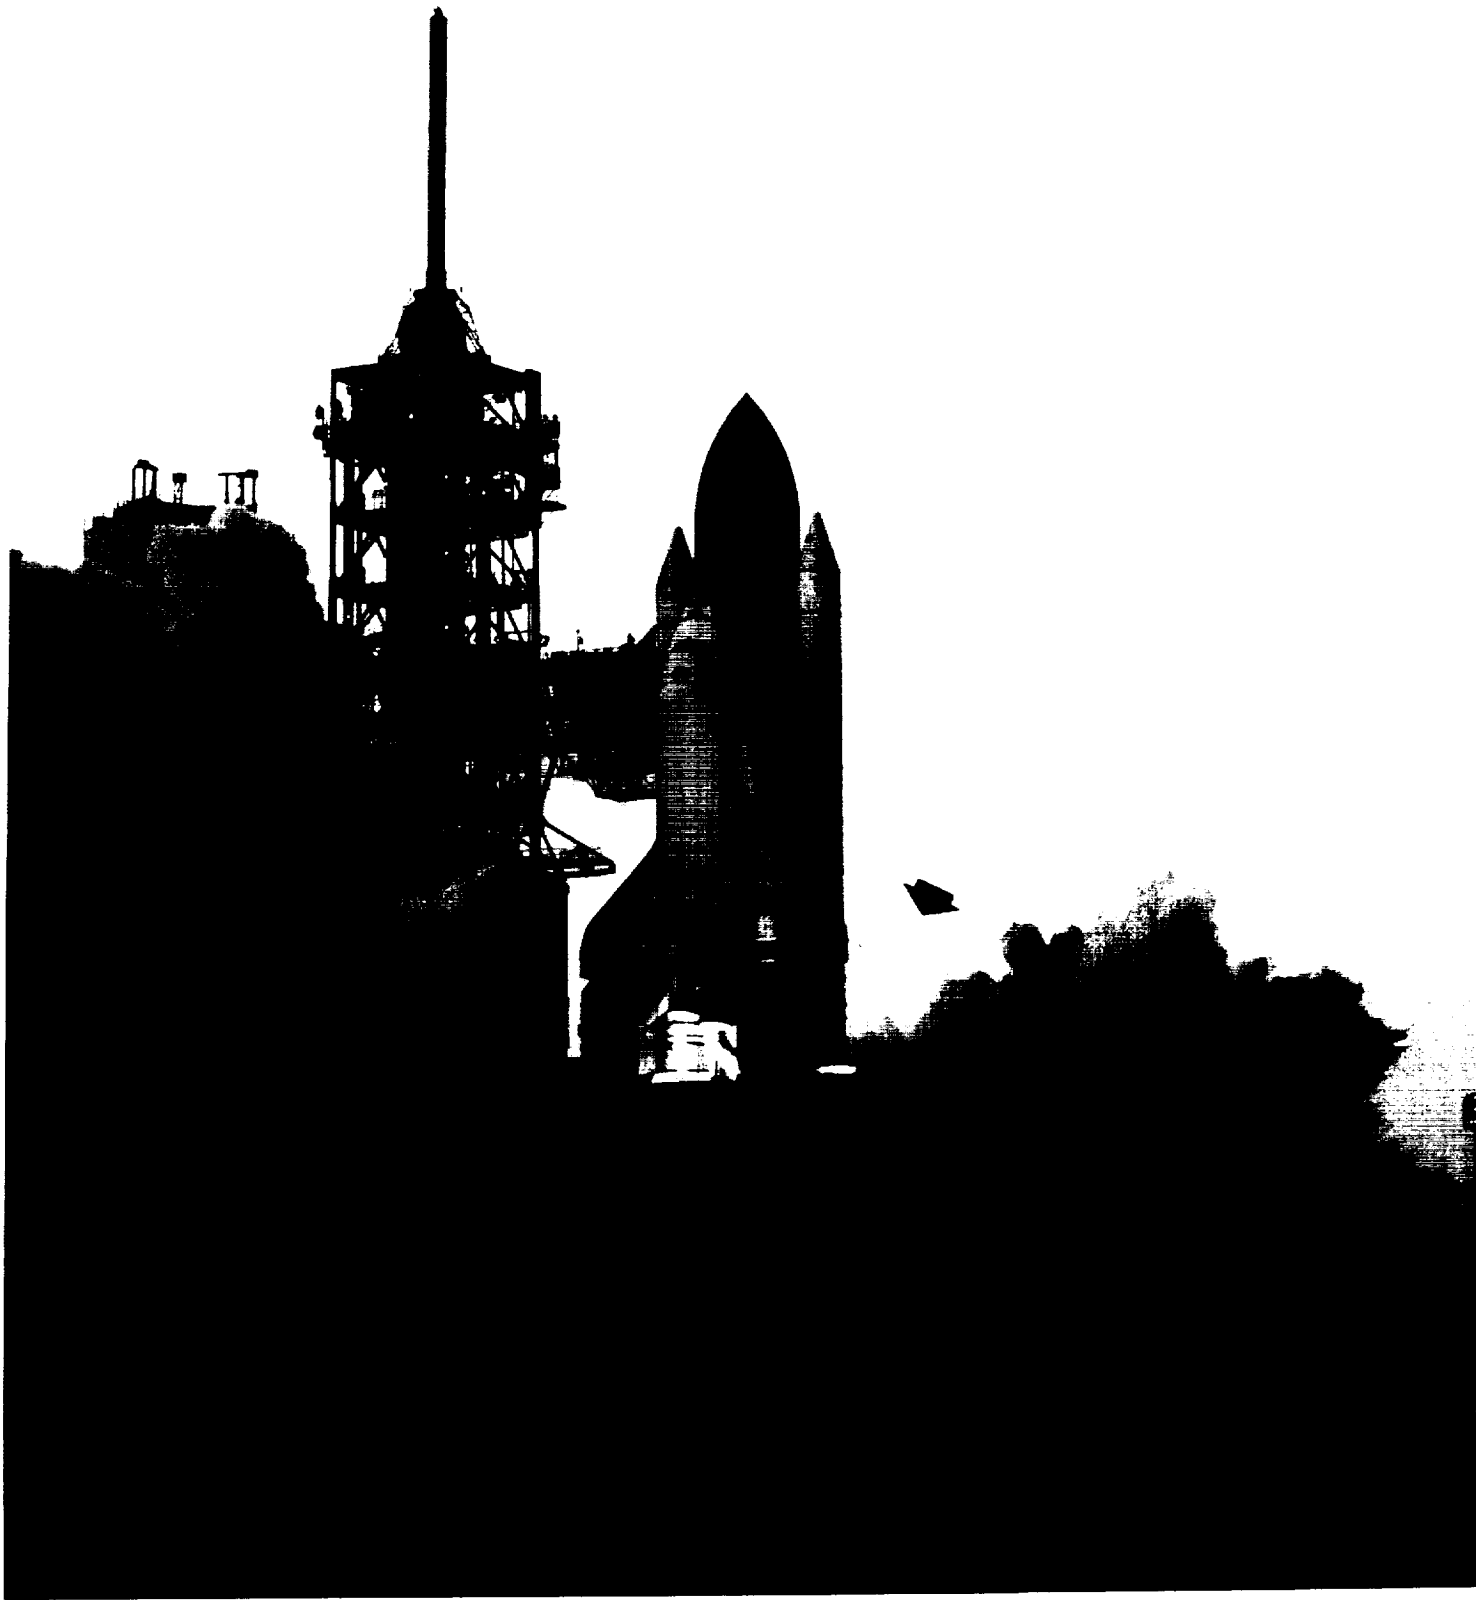
Numerous pieces of SRB throat plug material were ejected out of the SRB flame trench north of the vehicle. More SRB throat plug material was ejected upward out of the SRB exhaust holes. This is a common occurrence and none of the material was a threat to the vehicle.

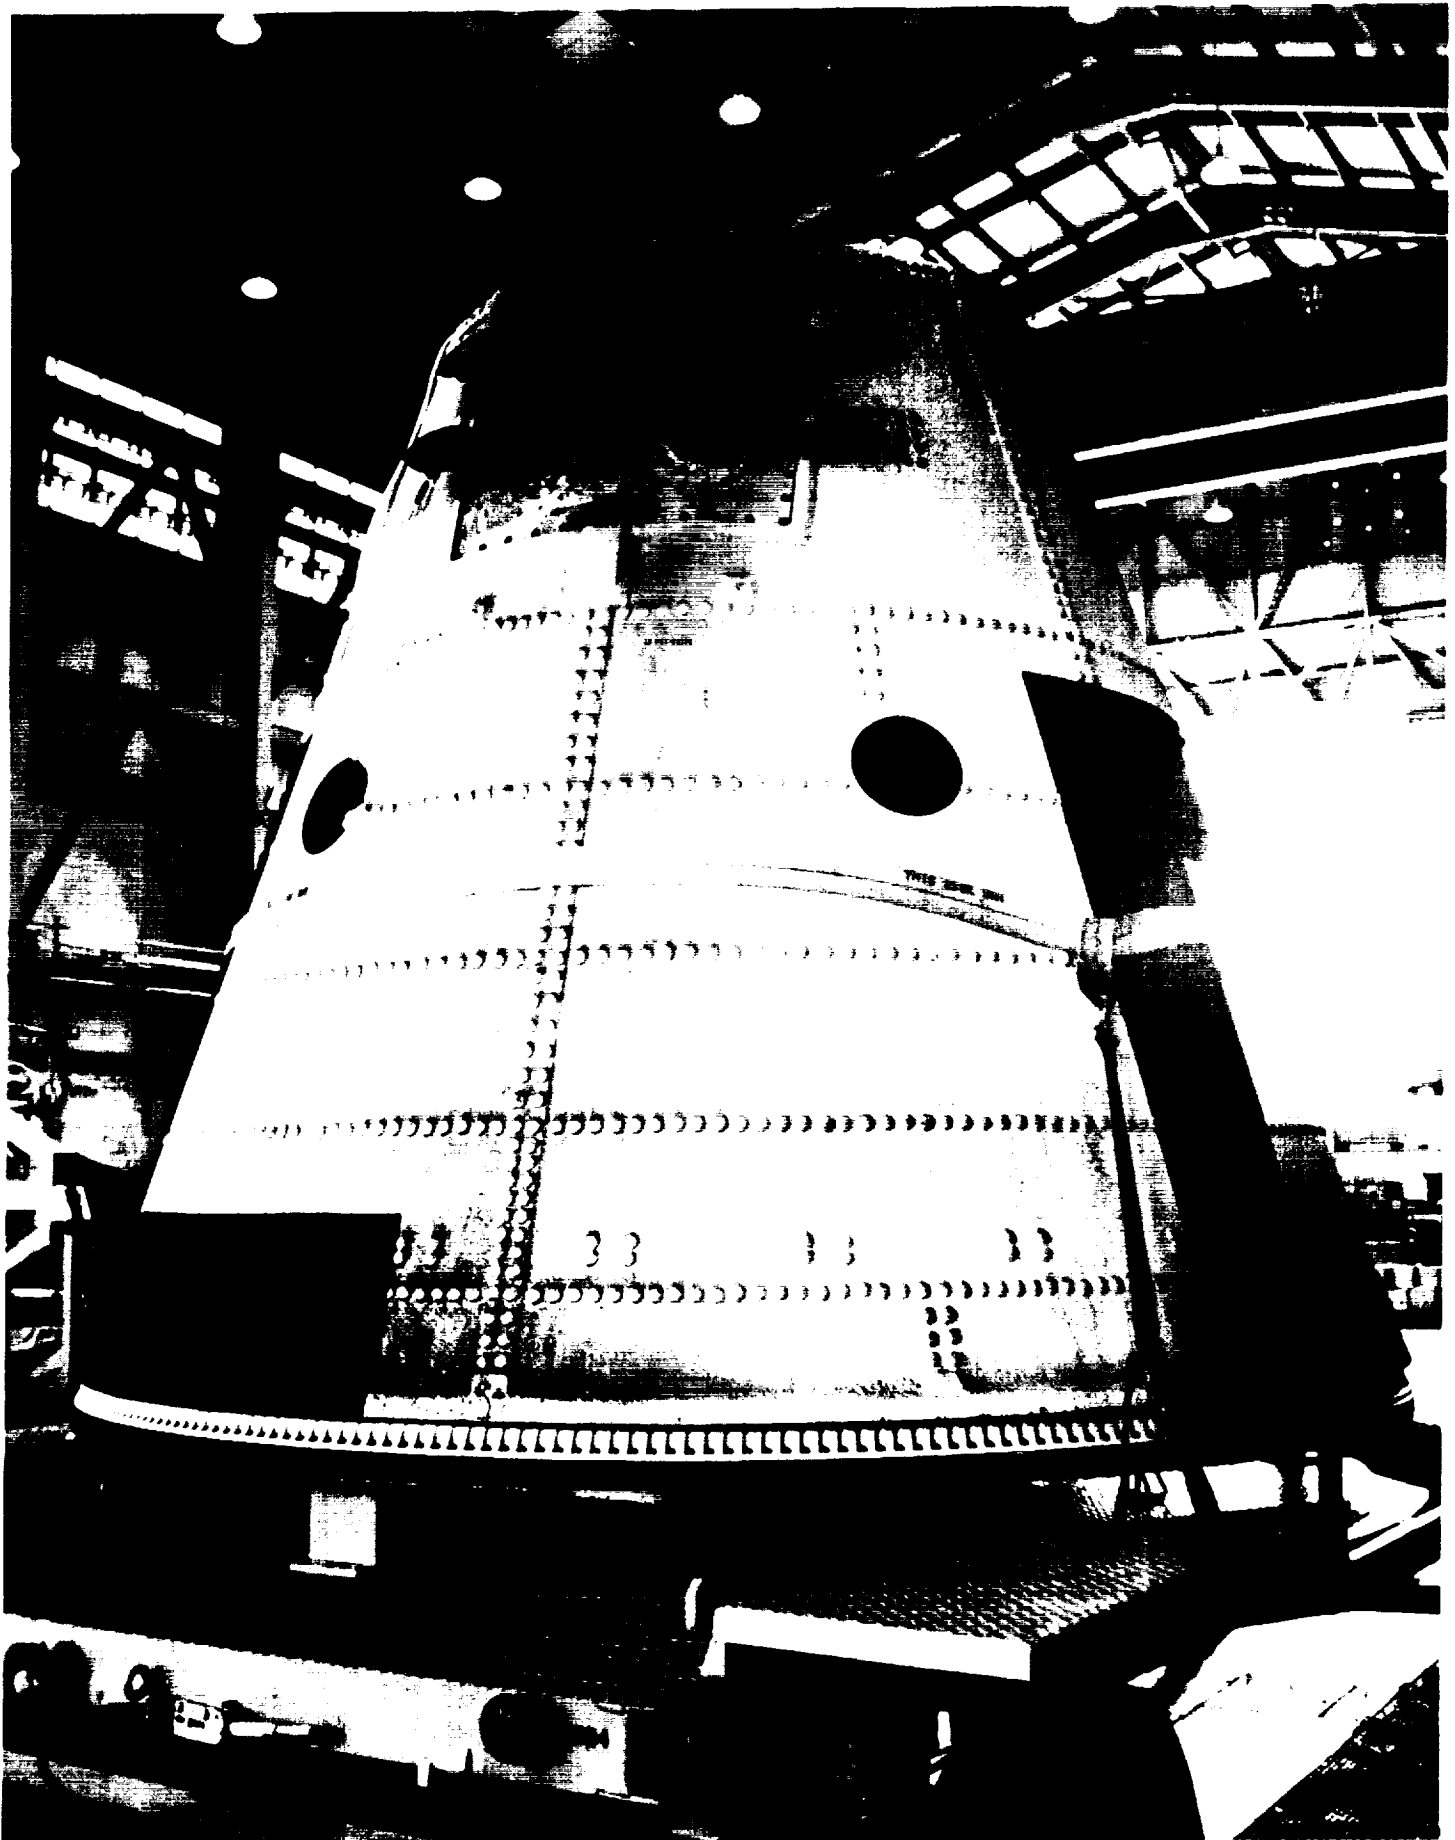
The RH frustum was missing no TPS but had 26 MSA-2 debonds over fasteners.

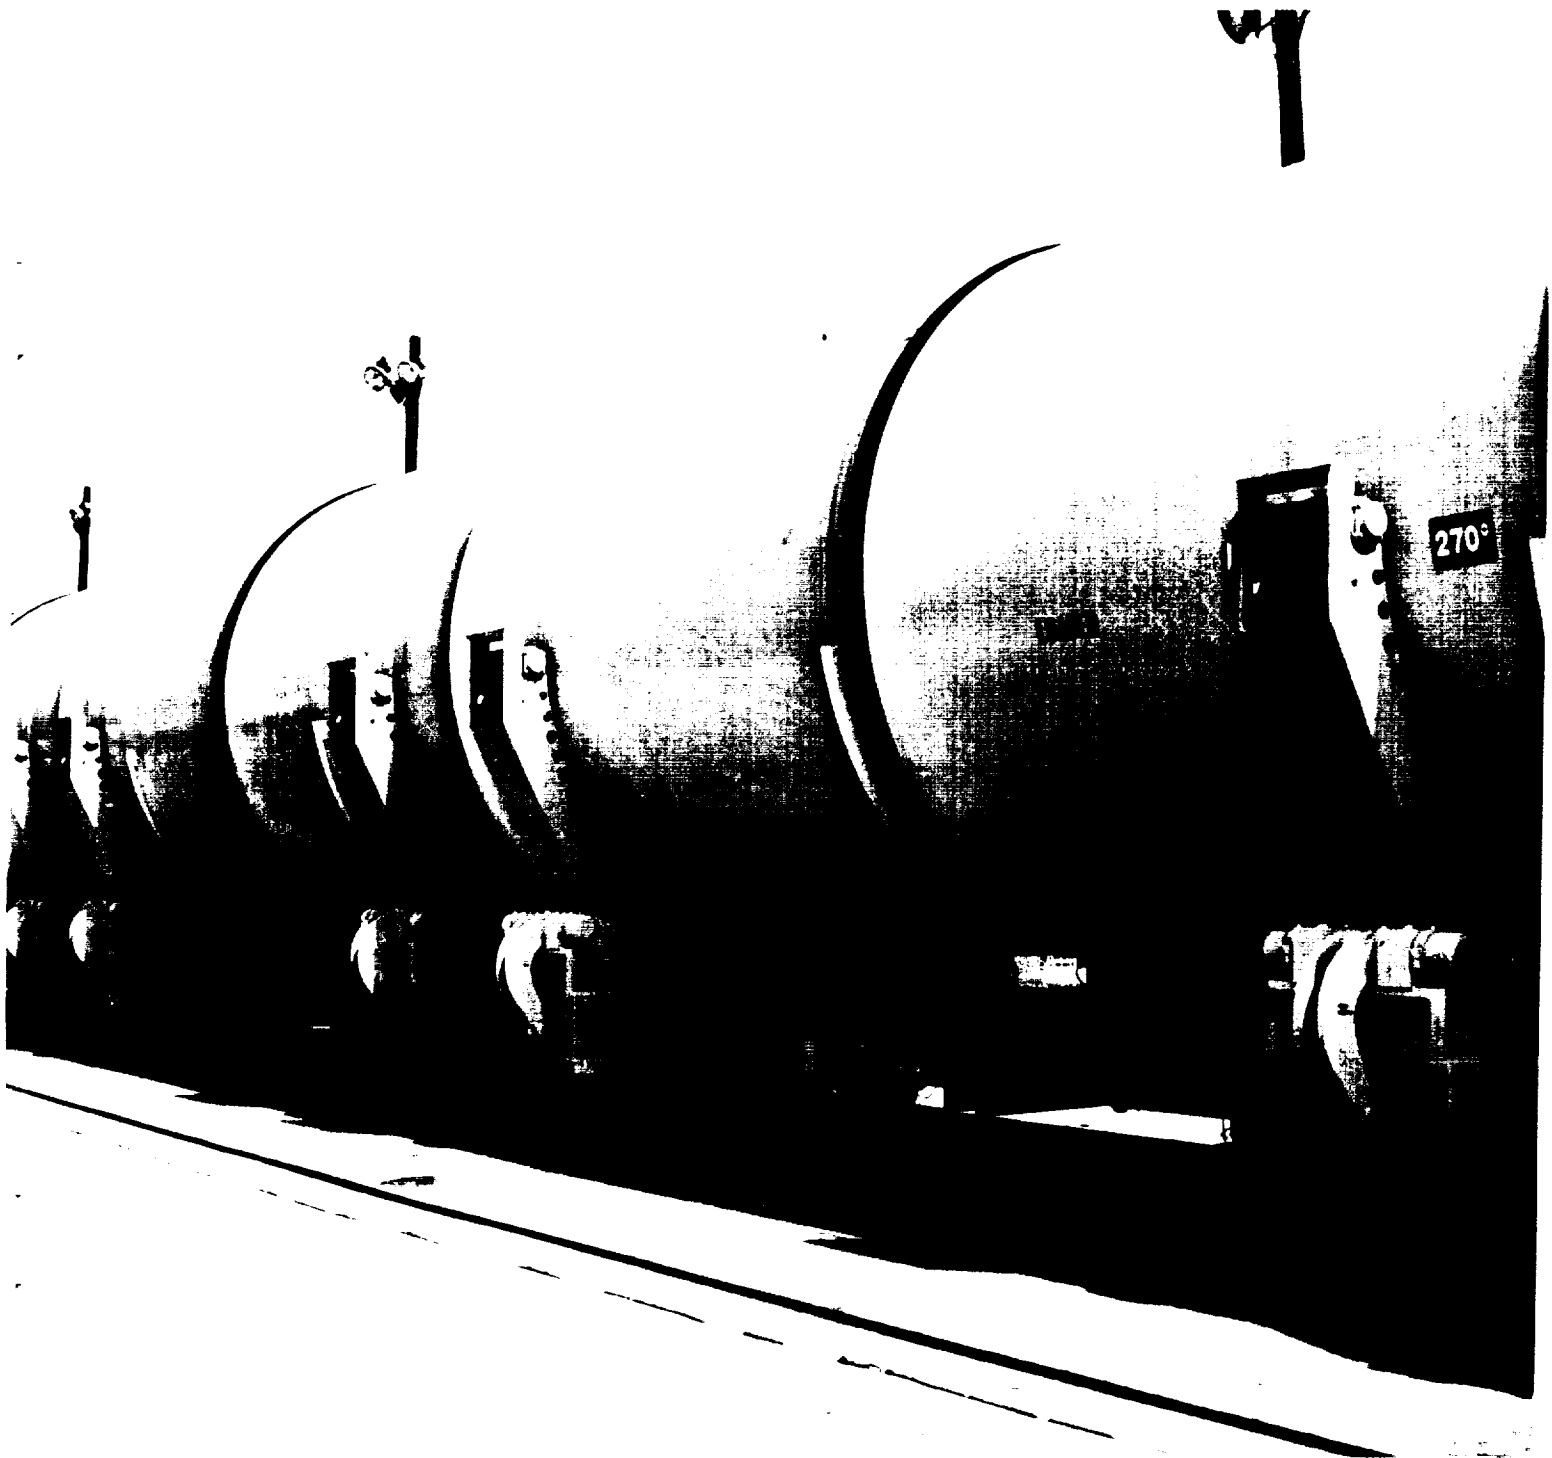
Overall view of the RH SRM cases. The Field Joint Protection System closeouts were generally in good condition.

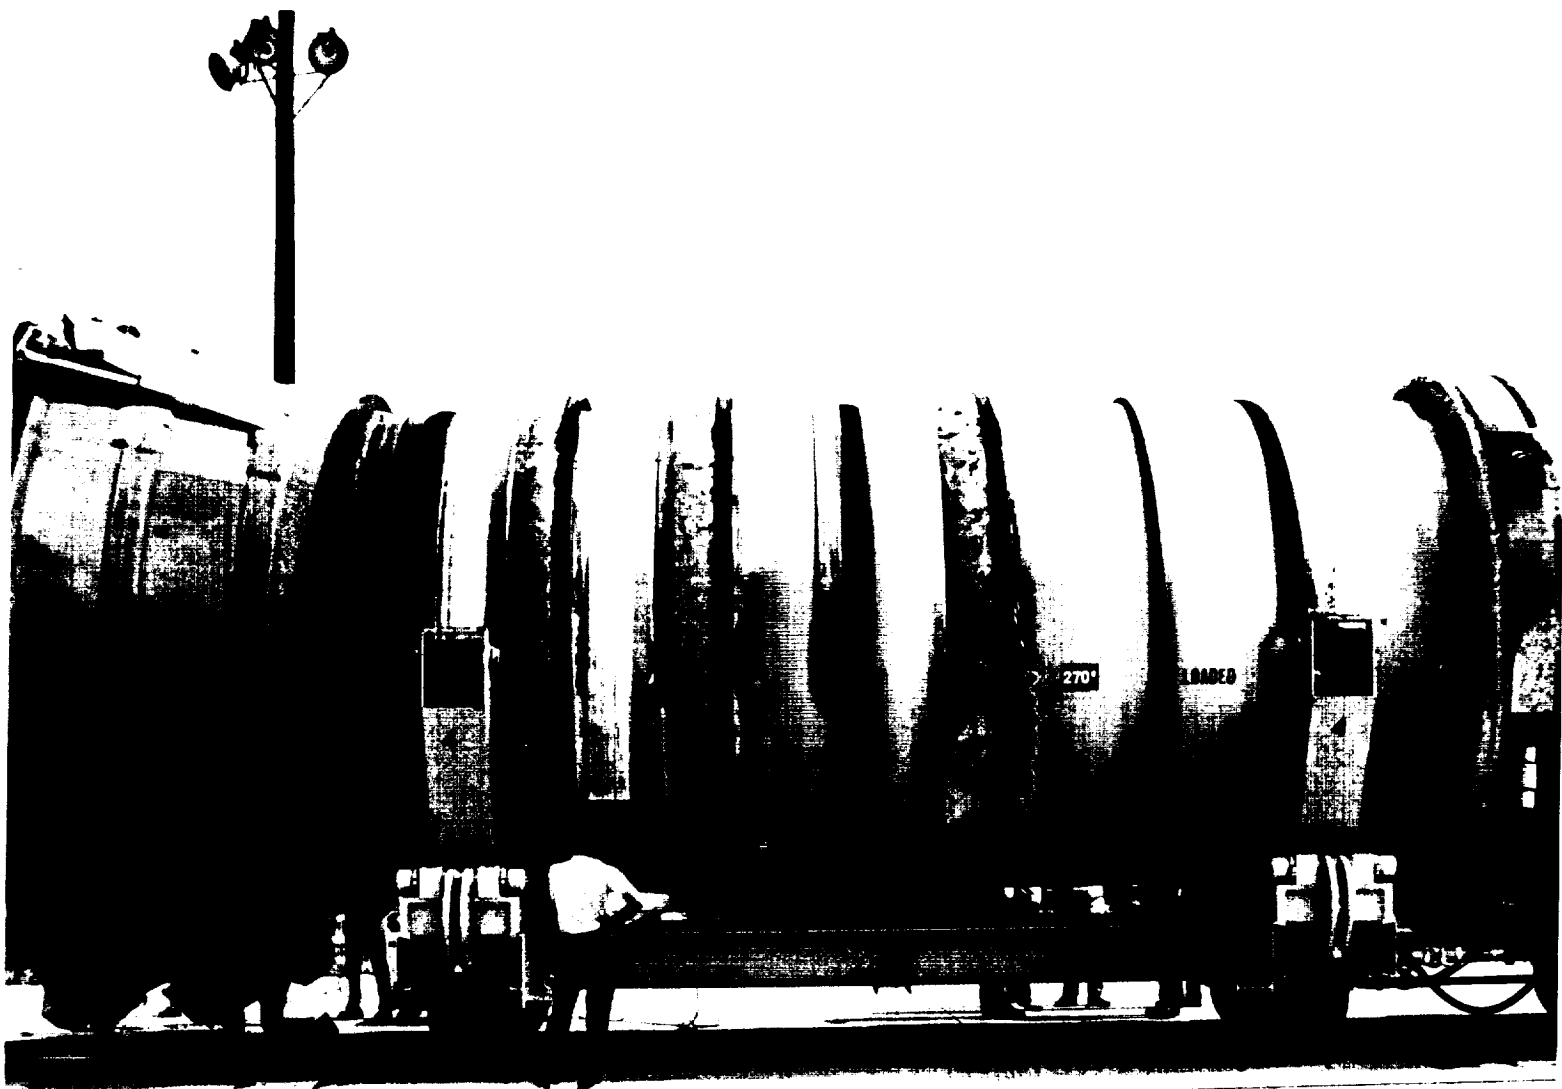
Post flight condition of the RH aft booster. The aft skirt  
acreaage TPS was sooted but in good condition.

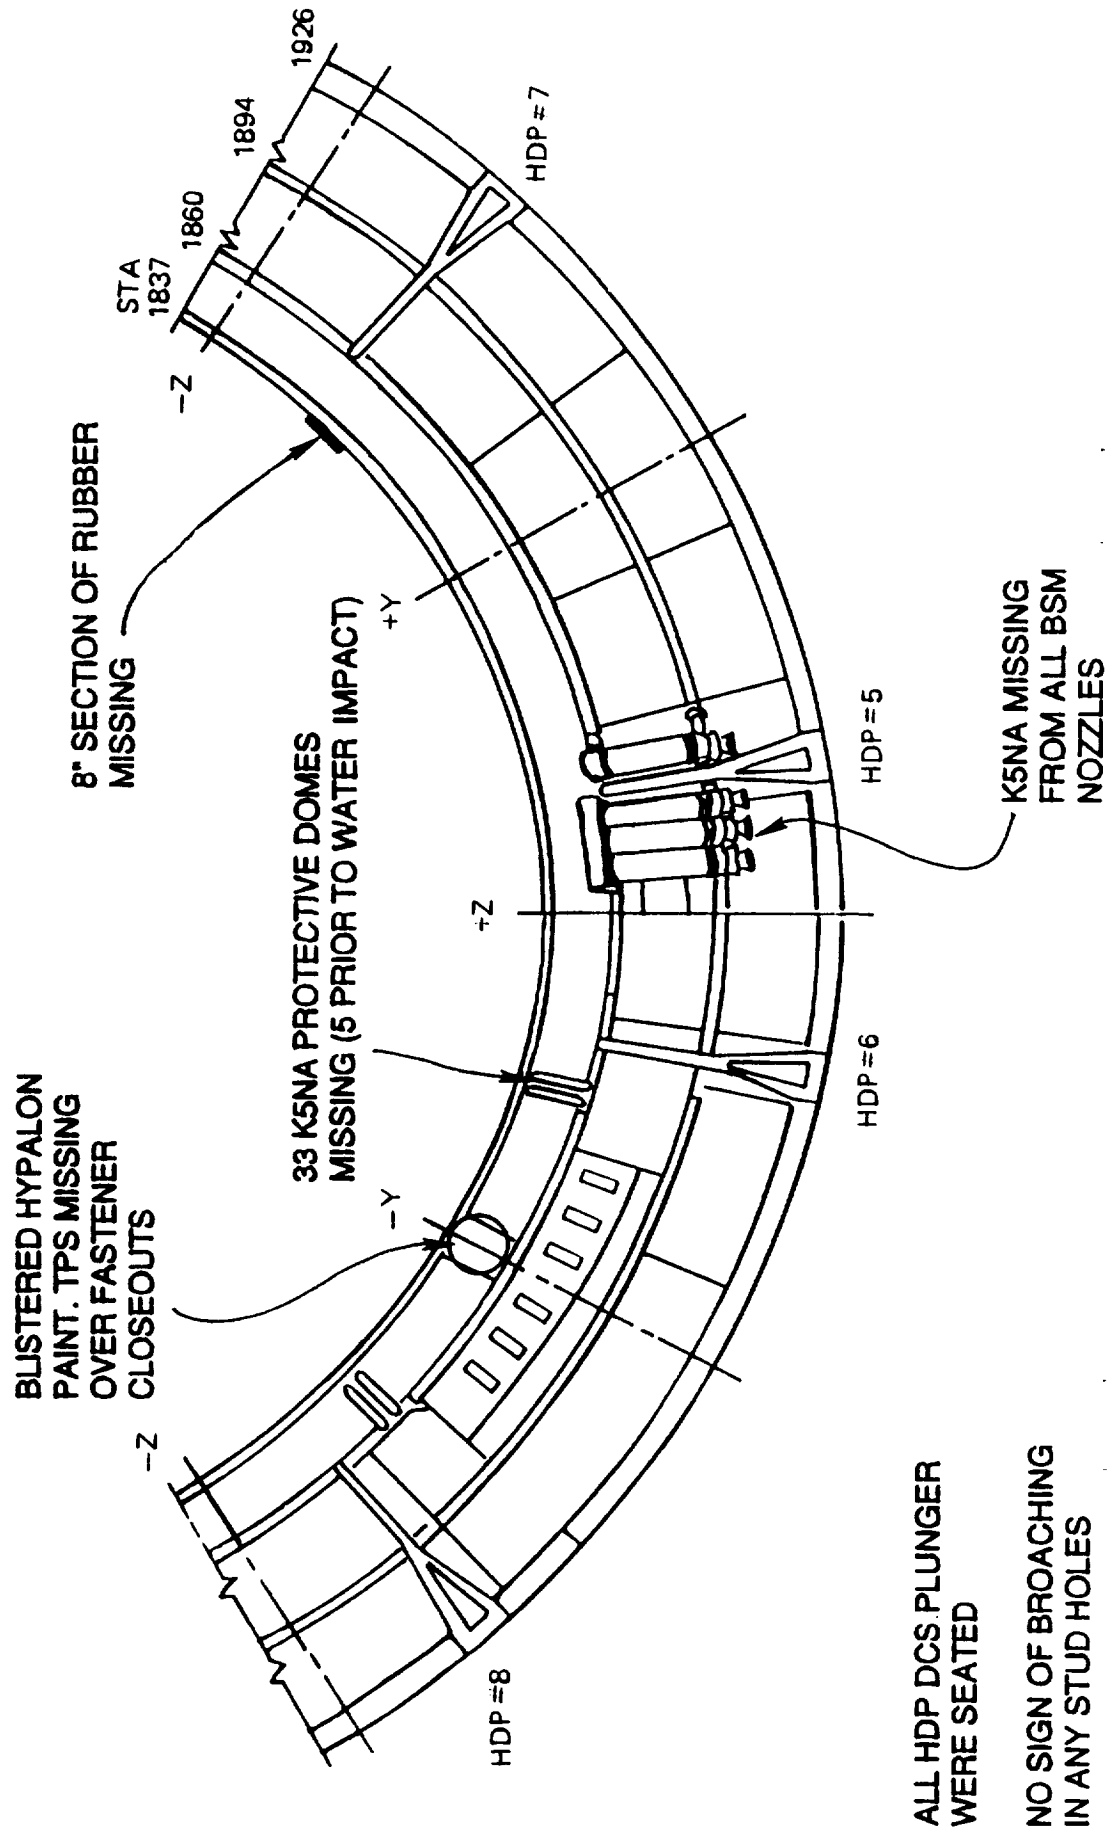
FIGURE 10. LEFT SRB AFT SKIRT EXTERIOR TPS

The phenolic material on the kick ring delaminated at several locations. Thirty-three K5NA protective dome were missing from bolt heads on the aft side of the phenolic kick ring. Five of these domes were lost prior to water impact (charred substrate). The aft skirt acreage TPS was in good condition. K5NA was missing from all aft BSM nozzles (Figure 10).
